US20 AT TUMALO

Infrastructure improvements at the intersection of O.B. Riley Road/Cook Avenue and US20

Site Location: Tumalo, OR

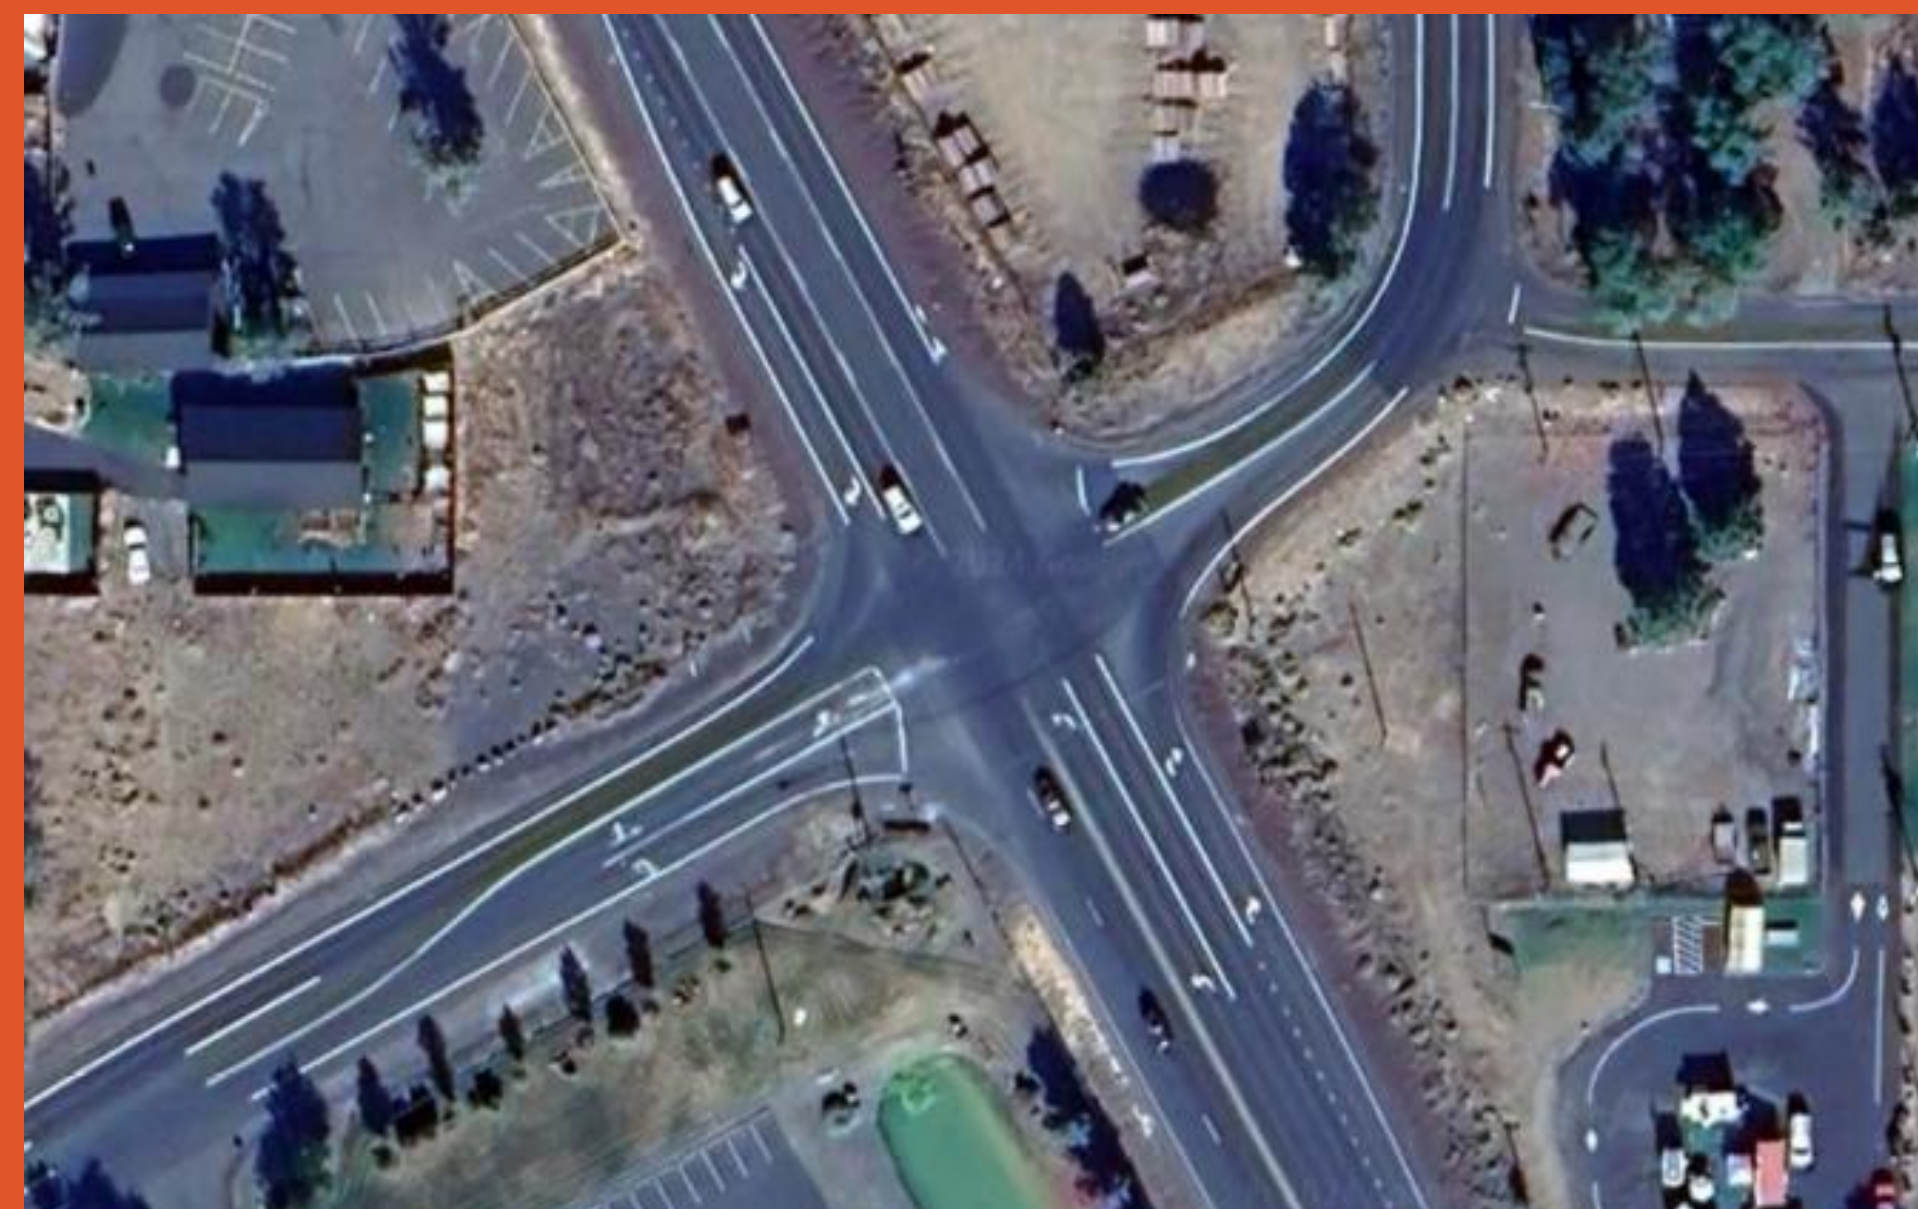
EXISTING INTERSECTION

- Two-way stop-controlled intersection in Tumalo, OR
- Located on highway US20—major freight route
- High traffic volumes
- History of angle crashes
- Mobility challenges for bicycles and pedestrians
- Deteriorating pavement

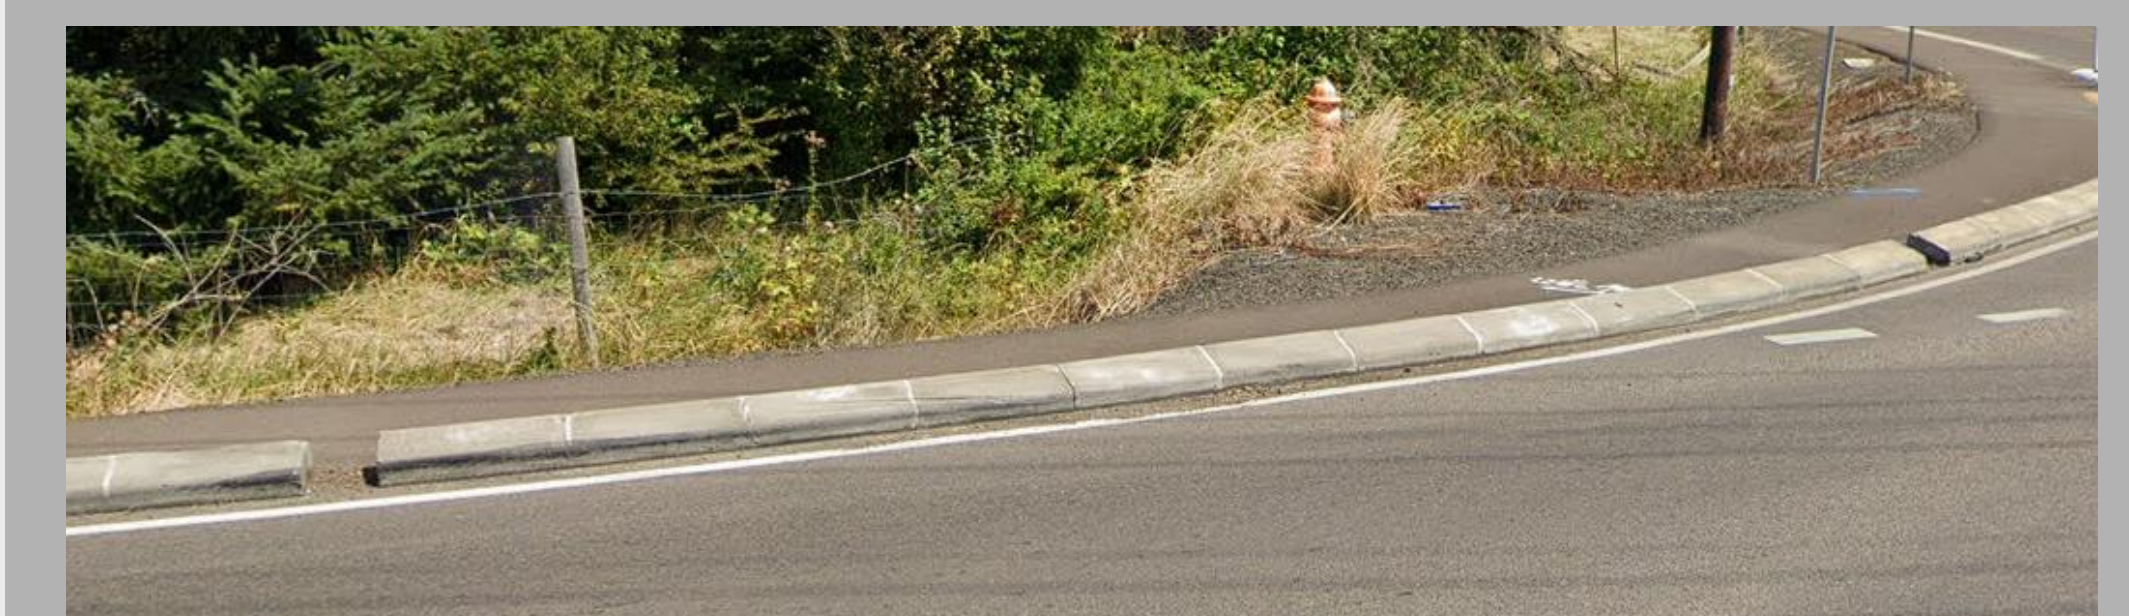
CURB CUTOUTS

The water resource engineers have been tasked with mitigating stormwater runoff at the Tumalo Intersection/Roundabout. Various considerations have been taken into account, including the efficiency of stormwater mitigation, the maintenance, and the overall aesthetic. The engineers have decided to design a system including retention ponds, storm drains, and curb cutouts.
