WOODEN BIKE FRAME DFM

Sponsor: Scott Campbell and Celilo Cycles

Team Members: Peter Barrette, Martin Hill, Philip

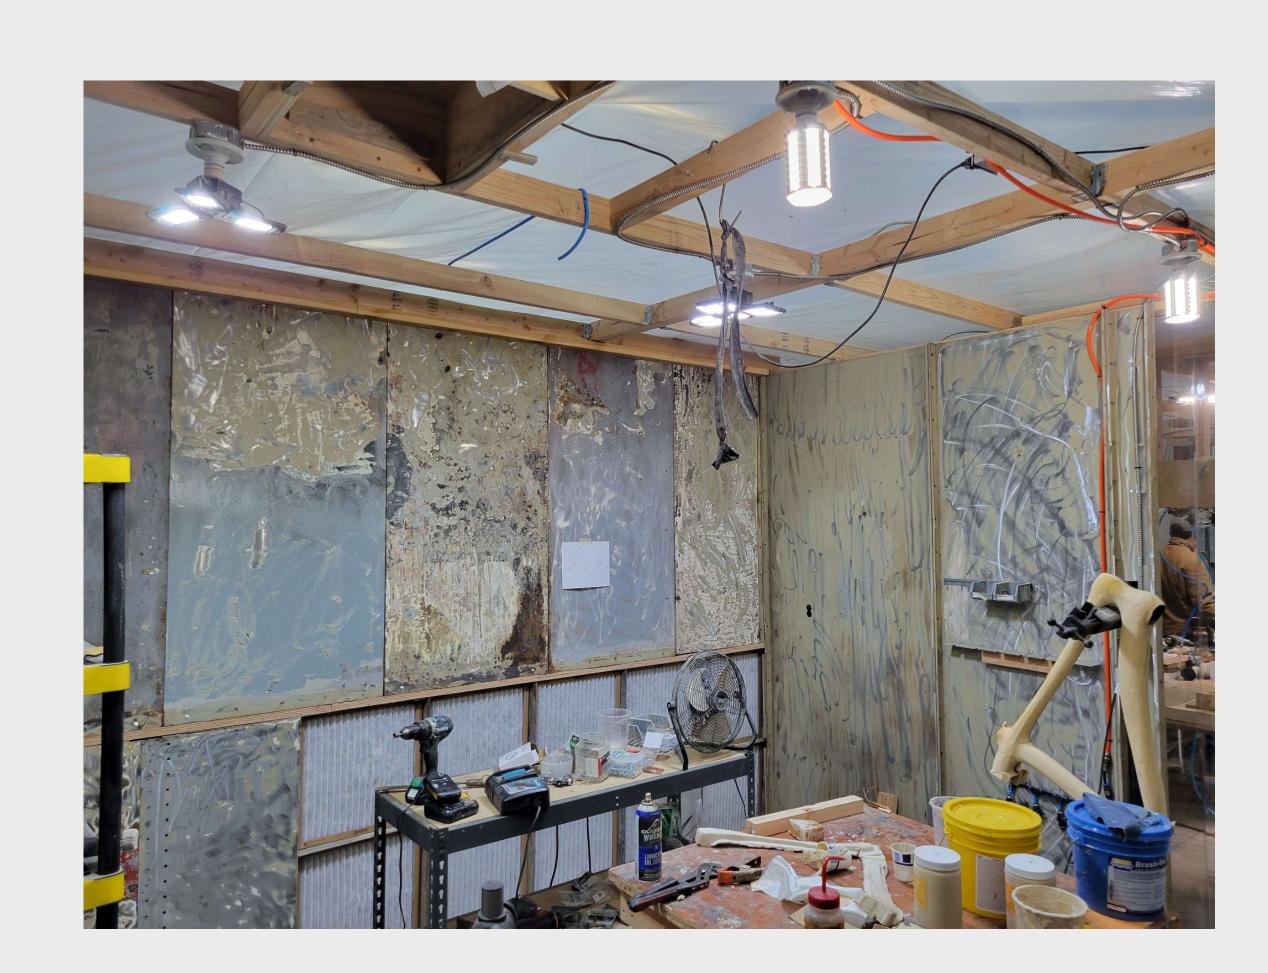
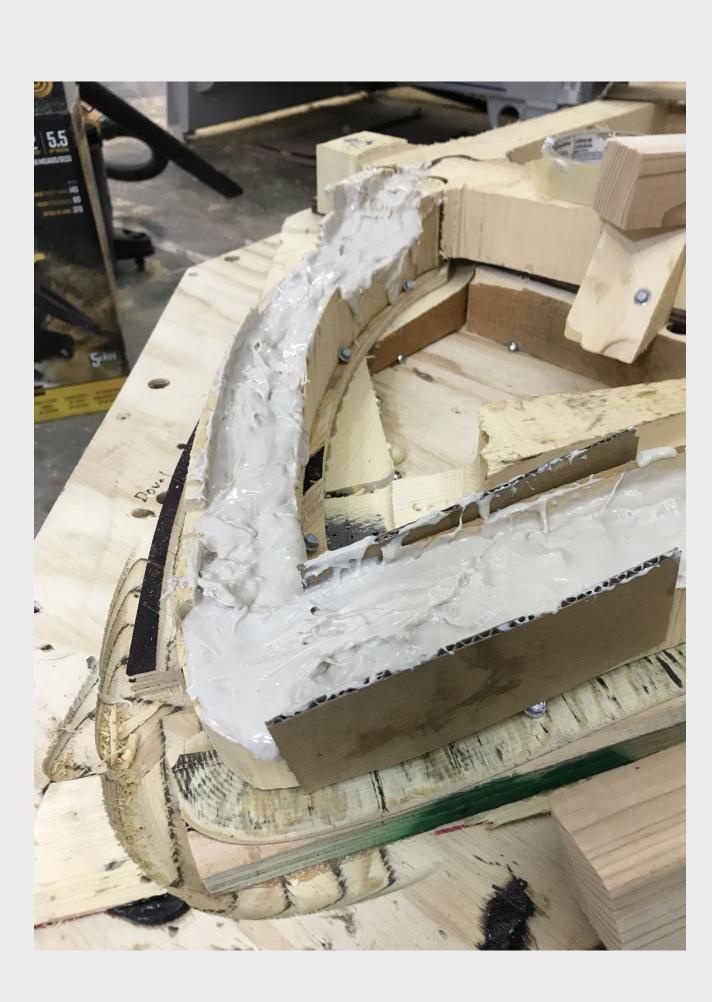
AIR BLADDER

- New bladder could supply 1.5x greater curing pressure.
- Carbon fiber cured directly to corners without gaps
- Improving the strength and durability of the frame
- The improved custom bladder results in a stronger bond.
 (compared the the right.)
- Image below shows one of the mold prototypes.
- Air bladder design helps reduce carbon layup process from 4 days to 1 day.

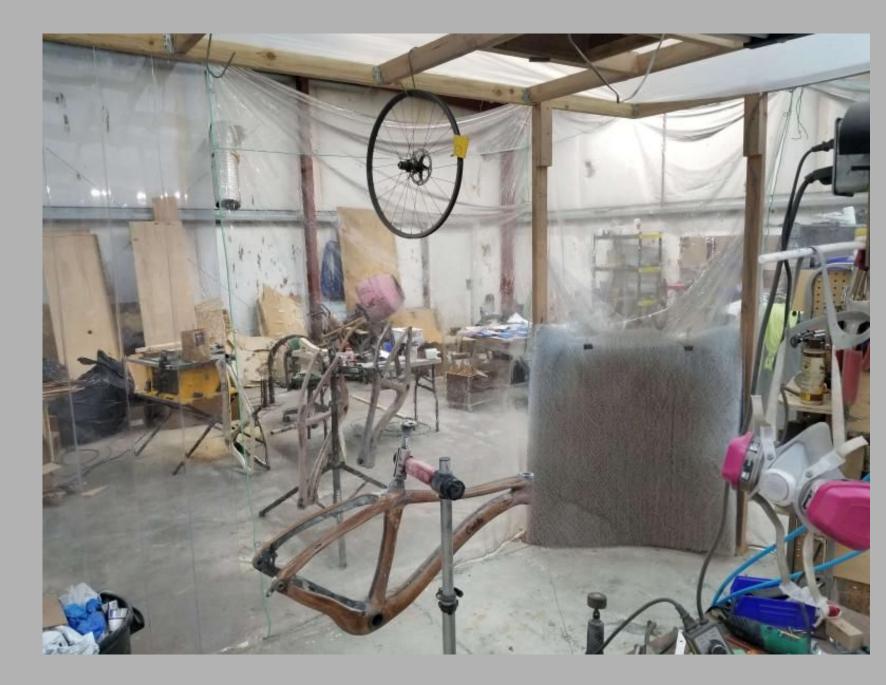
SANDING ROOM

- The original sanding room could not sufficiently pull debris from the work area.
- Debris would exit the sanding area and leave dust covering tools across the shop.

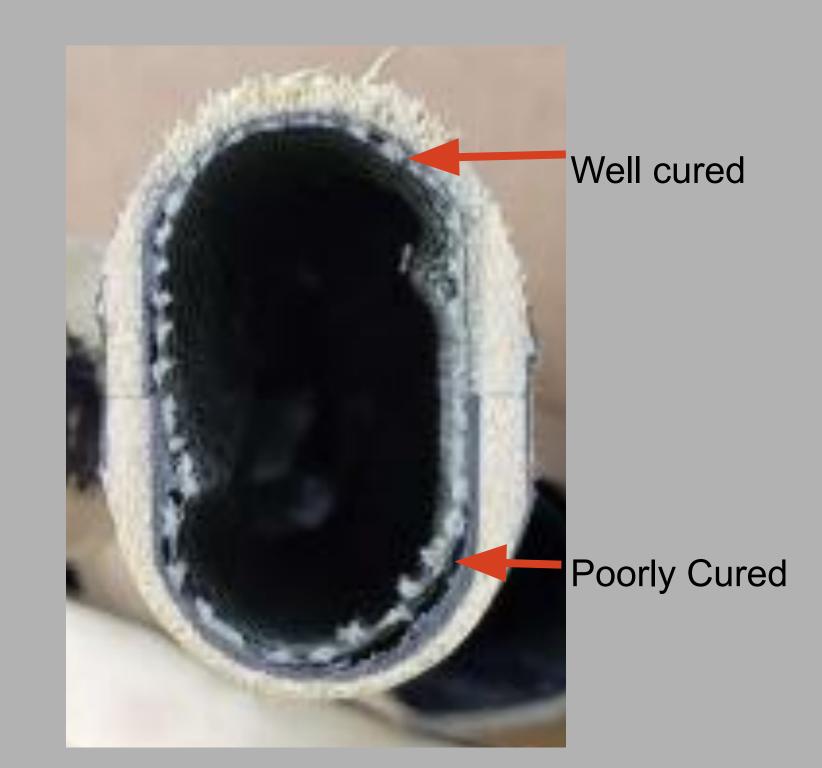
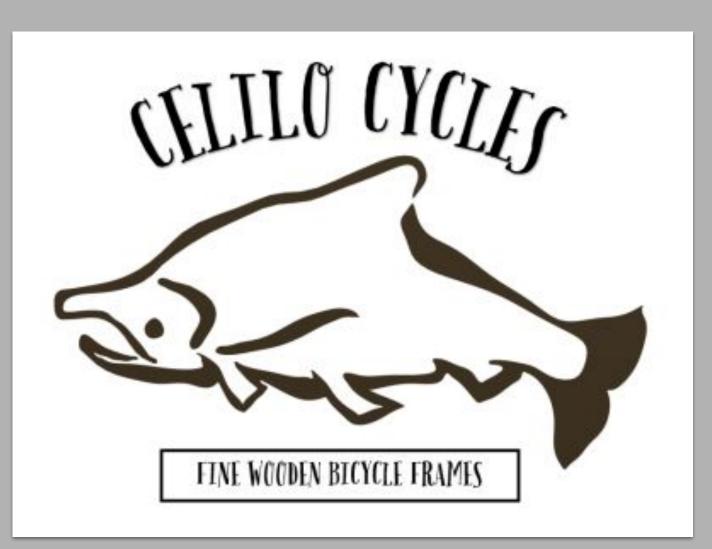
Air Bladder

- Bike inner tubes were used to press carbon sleeves into the frame while curing.
 - Inconsistent pressure left voids and had overall poor adhesion
